WATER SYSTEM TRANSFER IN OBONGI DISTRICT

ZONE 3 WATER SYSTEM ASSESSMENT REPORT **Doma, Luwakoke, Longa & Waka Schemes**

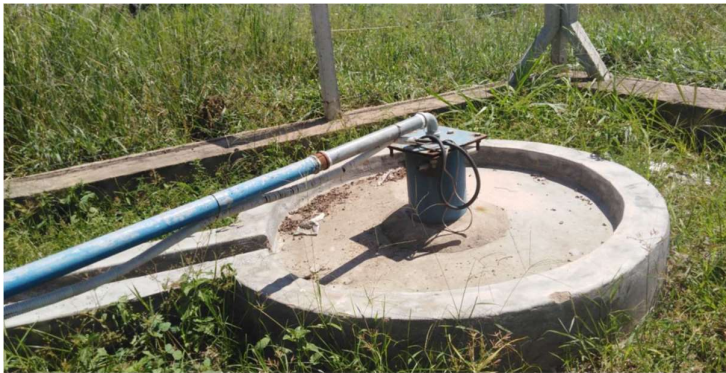
The water source for the Luwakoke water supply system is a borehole (DWD 69405) drilled at 108m depth, and with a pump test yield of 10m³/hr. The borehole is in good condition, since its completion in 2019.

A Grundfos SP11-33 pump is installed at depth 96m with a discharge Q of 11m³/hr. Based on the pump records, the pump is in operation for an average of 6 hours a day producing an average of 22m³/day.

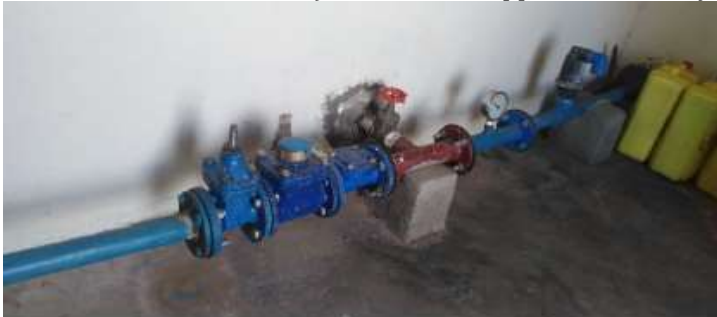
Well head fittings

The pump is installed with all the necessary pump control accessories (bulk meter, gate valves, air valve, non-return valve) and does not appear to have any leakages.

Ground water monitoring is done through assessment of bulk meter readings and pumping time. It is recommended that a piezometric monitoring system is installed to enable monitoring of ground water levels.

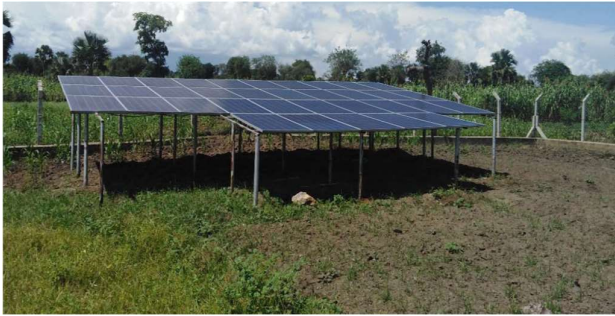
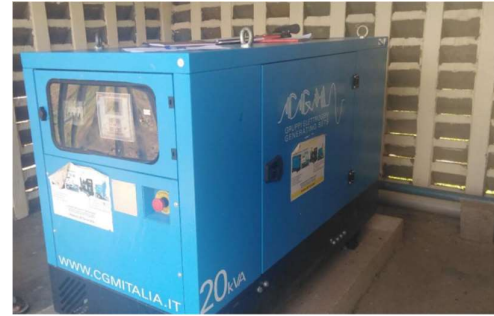
The energy source for the Luwakoke water system is a hybrid system comprising of a solar system and a thermal generator. There are 35No. BLD solar panels, each with a rating of 300W thus a theoretical capacity of 10.5KW which is adequate to power the pump (power rating of 7.5KW).

The solar system is backed up by a 20kVA diesel generator. The controllers for the pump and solar panels were observed to be in good condition.

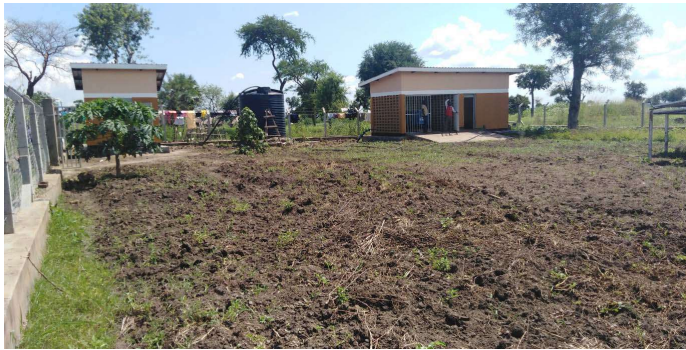
- i. The grounds are well secured using a chainlink fence. However the open area is being used as farmland.

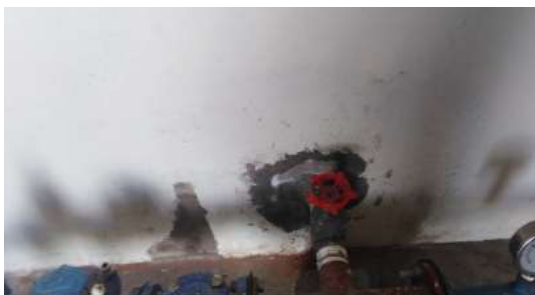
- ii. All civil structures are in generally good physical condition.
- iii. The pumphouse is in need of minor repairs to fix the cabling and pipe connections (see figures below for illustration).

Area that need repairs

O&M	Upgrade / Rehabilitation	
		Short-term	Medium-term
		<ul style="list-style-type: none"> - Minor repairs to fix the cabling and pipe connections. <p>Doma:</p> <ul style="list-style-type: none"> - Installation of lights in all structures. 	
Water Quality	<p>All schemes:</p> <ul style="list-style-type: none"> - Continuous water quality monitoring and reporting. 	<p>All schemes:</p> <ul style="list-style-type: none"> - Install chlorine dosing units for disinfection. 	
Storage	<p>All schemes:</p> <ul style="list-style-type: none"> - Regular maintenance and flushing of the reservoir are recommended 	<p>Luwakoke: Repair leakage on reservoir.</p> <p>Doma: Repair leakage on reservoir.</p> <p>Longa: Construction of 50 m³ storage tank.</p>	
Transmission and Distribution Networks	<p>All schemes:</p> <p>Regular flushing of water mains</p>	<p>All schemes:</p> <ul style="list-style-type: none"> - Carry out investigations to identify the pipe lengths and diameters. - Carry out hydraulic designs and mapping of the systems. - Install network fittings including control valves, air release valves, wash-outs, marker posts etc. - Expansion of the tertiary distribution networks to increase coverage.

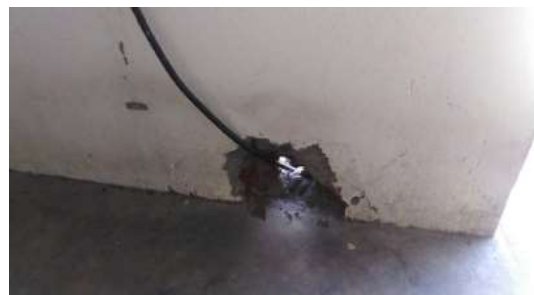
Cable from the borehole to the pump house, repairs need to be done

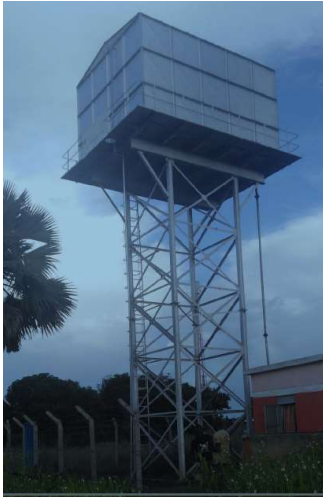
A 108m³ steel tank is erected 10m above the ground. The field visit observed a leakage on the tank.

v. Metering PSPs (new and current)		10	133,200	1,332,000
vi. Chlorination unit		1	24,000,000	24,000,000
vii. Repair leakage on reservoir				300,000
viii. Replace pump (Q=9 m3/h) to meet resource capacity, incl. motor and control panel		1	20,000,000	20,000,000
ix. Repair broken taps		3	50,000	150,000

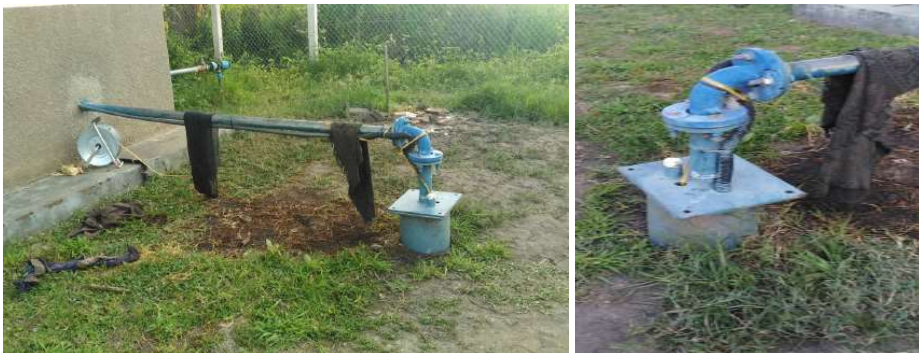
The water source for the Doma water supply system is a borehole (DWD 69225) drilled at 125.5m depth, and with a pump test yield of 15m³/hr. The borehole is in good condition, since its completion in 2018.

A Grundfos SP9-25 pump is installed at depth 109m with a discharge Q of 9m³/d. Based on the pump records, the pump is on operation for an average of 17 hours a day producing an average of 72m³/day.

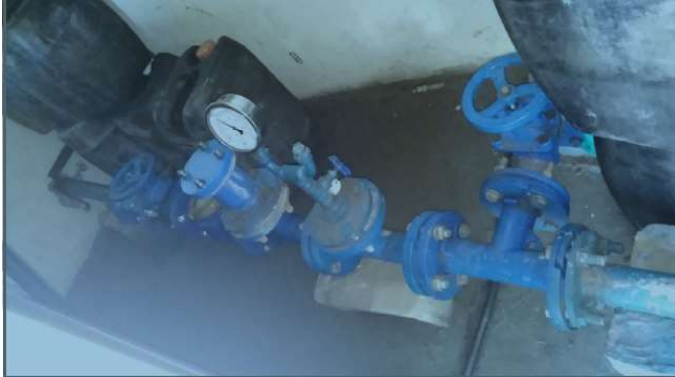
The pump is installed with all the necessary pump control accessories (bulk meter, gate valves, air valve, non-return valve) and does not appear to have any leakages.

Ground water monitoring is done through assessment of bulk meter readings and pumping time. It is recommended that a piezometric monitoring system is installed to enable monitoring of ground water levels.

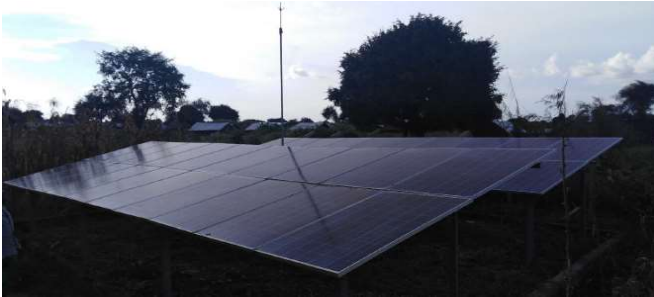
The energy source for the Doma water system is a hybrid system comprising of a solar system and a thermal generator. There are 40No. Risun solar panels, each with a rating of 265W thus a theoretical capacity of 10.6KW which is adequate to power the pump (power rating of 5.5KW). The solar system is backed up by a 17kVA diesel generator. The controllers for the pump and solar panels were observed to be in good condition.

Based on pump records, the system is heavily dependent on the generator, with an average of 63% production based on the thermal generator during the period May – July 2020.

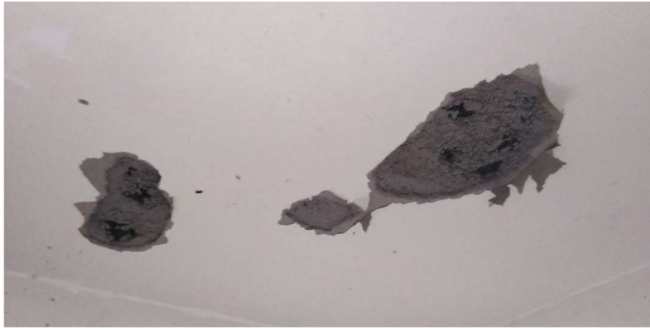
- i. The pump house is currently used as pump house and generator house. There is no space to access the well head fittings.
- ii. All civil structures are in good physical condition. However, the grounds are being used as farmland.
- iii. The guard house is also used as a store. There is need to repair patches in ceiling (see figure below for illustration).
- iv. There are no lights installed in the guard and pump houses.

Section of the ceiling in the guardhouse that need repairs

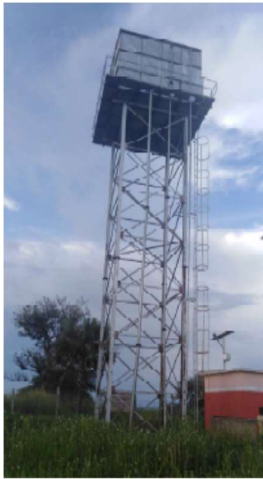
The system has a total storage capacity of 65m³ in steel tank erected 15m above ground as shown below. The field visit observed leakage on the tank.

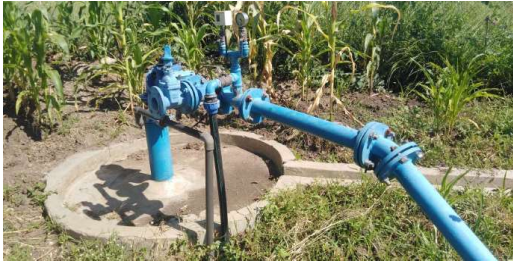
The water source for the Longa I water supply system is a borehole (DWD 66773) drilled at 90m depth, and with a pump test yield of 16.2m³/hr. The borehole is in good condition, since its completion in January 2017.

A Grundfos SP17-9 pump is installed at depth 90m. Based on the pump records, the pump is in operation for an average of 19 hours a day producing an average of 156m³/day.

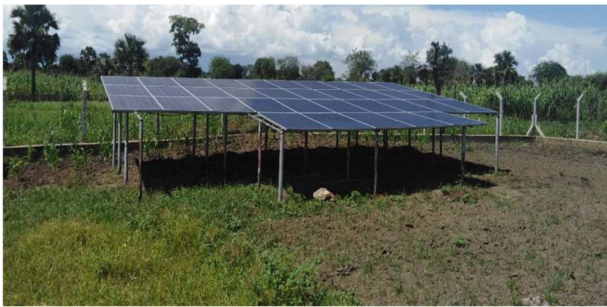
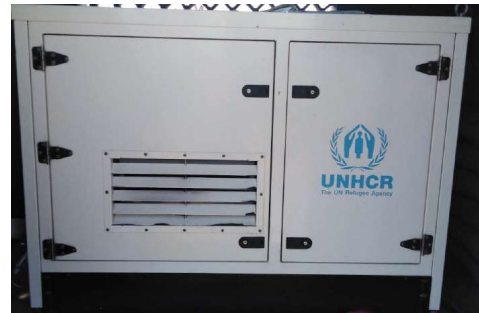
The energy source for the Longa I water system is a hybrid system comprising of a solar system and a thermal generator. There are 72No. Solinic solar panels, each with a rating of 120Wp thus a theoretical capacity of 8.64KW which is adequate to power the pump (power rating of 5.5KW). The solar system is backed up by a 25kVA diesel generator. The controllers for the pump and solar panels were observed to be in good condition.

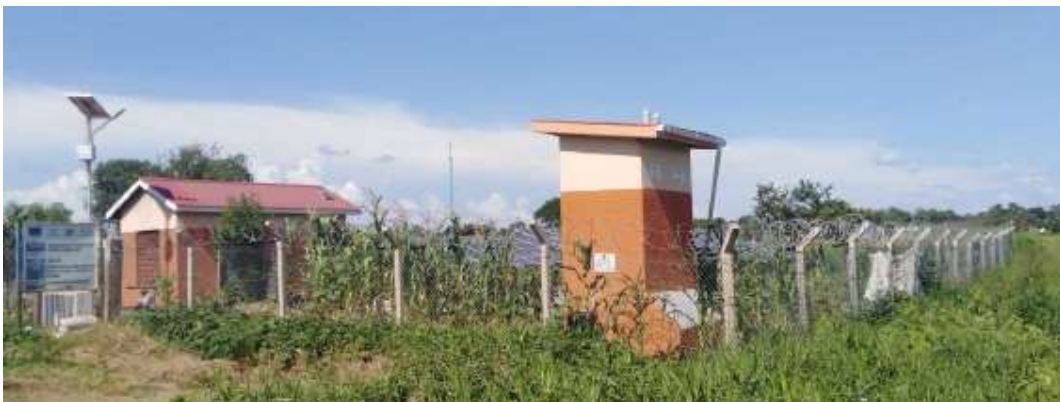
The civil structures include a pumphouse, a generator house, a guardhouse and an ecosan latrine. All civil structures are in good physical condition. However, the grounds are being used as farmland.

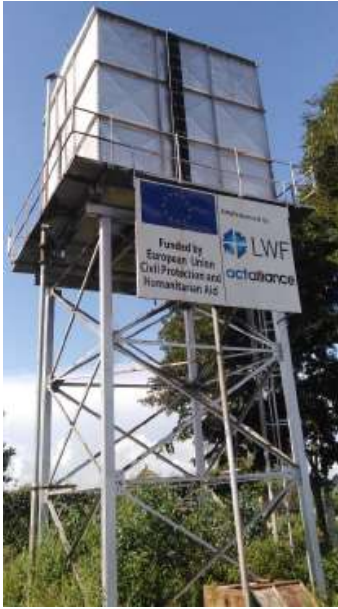
A 50m³ steel tank is erected above-ground.

- In the short-term, install additional storage capacity in the Longa I water system. In the long term, install additional storage capacity in the Waka system to meet the 2040 demand.
- It is recommended that all systems undergo hydraulic designs to optimize the reserve storage capacity between schemes and potential for network integration. For example, initial investigations show that integrating the Longa I and Longa II systems may provide adequate storage and postpone the need for construction of an additional storage tank.

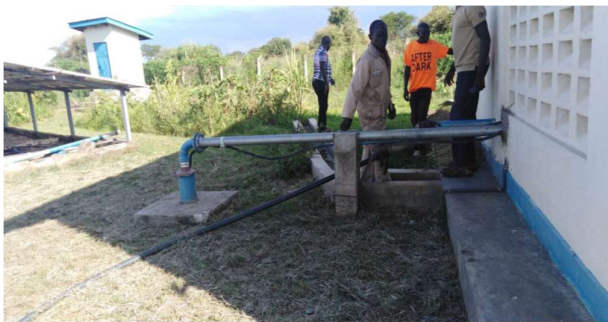
The water source for the Waka water supply system is a borehole drilled at 66.31m depth, and with a pump test yield of 15m³/hr.

Although the site is in fairly good condition, it faces challenges of accessibility during the rain seasons.

O&M	Upgrade / Rehabilitation	
		Short-term	Medium-term
Water Source: Borehole and Pump	<p>All boreholes:</p> <ul style="list-style-type: none"> - Flushing / de-silting of the boreholes. 	<p>All boreholes:</p> <ul style="list-style-type: none"> - Carry out test-pumping of all boreholes to determine the actual yield. <p>Luwakoke:</p> <ul style="list-style-type: none"> - Replace pump (Q=9 m³/h) to meet resource capacity. 	<p>All boreholes:</p> <ul style="list-style-type: none"> - Install piezometric monitoring systems on all boreholes to enable real-time monitoring of ground water levels. <p>Luwakoke:</p> <ul style="list-style-type: none"> - Installation of additional borehole (Yield 53 m³/d) and pump. <p>Longa:</p> <ul style="list-style-type: none"> - Installation of additional borehole (Yield 108 m³/d) and pump. <p>Waka:</p> <ul style="list-style-type: none"> - Installation of additional borehole (Yield 129 m³/d) and pump. - Rehabilitate the road to improve accessibility to the site.

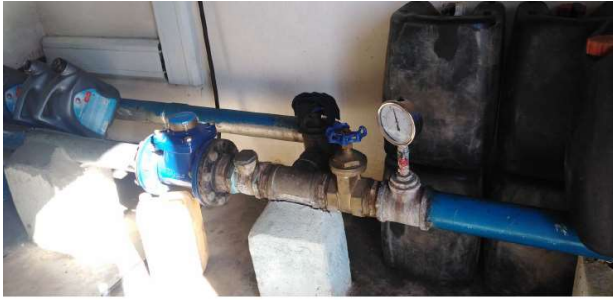
A Grundfos SP9-29 pump is installed at depth 51m. Based on the pump records, the pump is in operation for an average of 20 hours a day producing an average of 192m³/day.

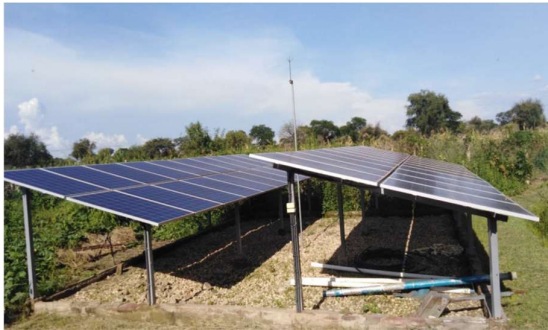
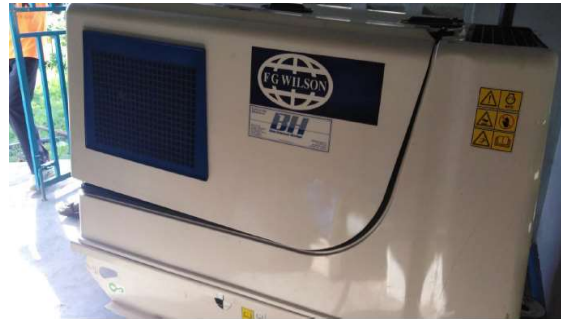
The energy source for the Waka water system is a hybrid system comprising of a solar system and a thermal generator. There are 40No. Risun solar panels, each with a rating of 265W thus a theoretical capacity of 10.6KW which is adequate to power the pump (power rating of 5.5KW). The solar system is backed up by a 13.5kVA FG Wilson diesel generator. The controllers for the pump and solar panels were observed to be in good condition.

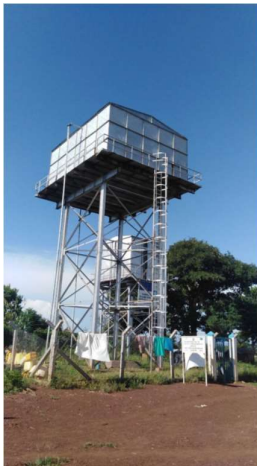
A 125m³ steel tank is erected 10m above the ground.
